Sensicast Chiller Monitoring Application Reduces Cost

SensiNet® Chiller Plant Monitoring System Reduces Operating Costs and Predicts Equipment Failure

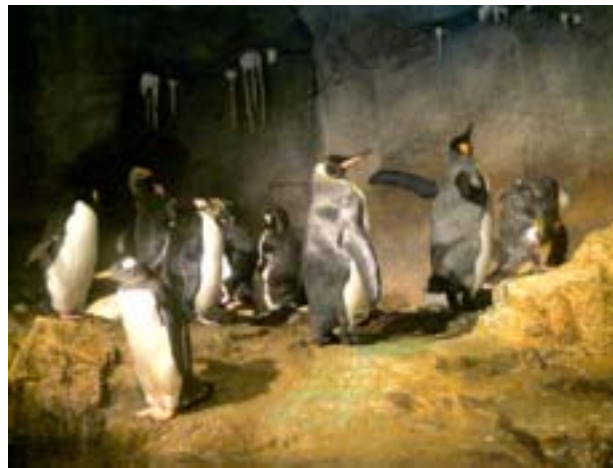
Figure 1 -Spectator View of Penguin Exhibit at the Pittsburgh Zoo & PPG Aquarium

The SensiNet Smart Sensors were quickly and unobtrusively installed and, as seen in **Figure 1**, not visible to spectators. Since they are battery operated with batteries lasting up to three years, installation was fast and easy. The installation of wired sensors would have required the cutting through the concrete and simulated rock and disruption of the exhibit.

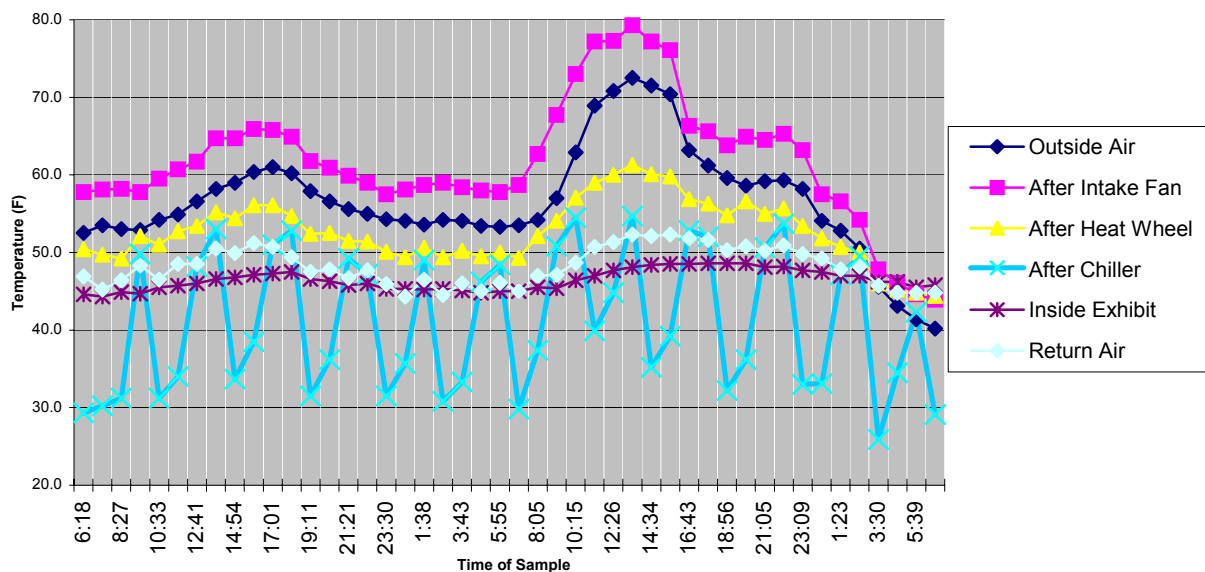
Figure 5 – Sample of Thermal Performance of Air Chiller from Two-Day Period

Temperature/humidity sampling intervals of one- to two-minutes were easily set using the SensiMesh® software to correspond with the sampling rate inside the exhibit. During the two-day sampling period, the outside air temperature varied from a minimum of 40.2° F to a maximum of 72.5° F. The temperature after the intake fan is typically 4°F to 7°F higher than the outside air due to heat from the fan motor in the compartment. The temperature after the

enthalpy wheel shows that as the outside temperature increases, the temperature drop across the enthalpy wheel increases. The exhibit temperature varied from a minimum of 44.3° F to a maximum of 48.6° F.

The most interesting response was shown by the temperature in the compartment just downstream of the air chiller heat exchanger.

The air chiller heat exchanger is divided into an upper and a lower section. For two hours, airflow doors are opened to the upper heat exchanger and coolant flows to cool the air. Then the upper airflow doors close, the lower airflow doors open and cold coolant flows to cool air through the lower heat exchanger. This process is used to preclude the buildup of ice during periods of high humidity

This led to the examination of the detailed data collected every two minutes. Temperature indications from the SensiNet Temperature node indicated that for two hours the temperature of air around the wireless sensor was approximately 30° F lower than the temperature reading in the upstream compartment when the upper chiller air flow doors were open. However, during the next two-hour period, when the lower compartment air flow doors are open, the temperature at the SensiNet Temperature node was only approximately 12° F lower than the temperature reading in the upstream compartment.
